A Relay Fragility Test Experience of Nuclear Power Plant in Taiwan

Ying-Dar Tseng
Institute of Nuclear Energy Research
Taiwan, Republic of China
2015.08.24

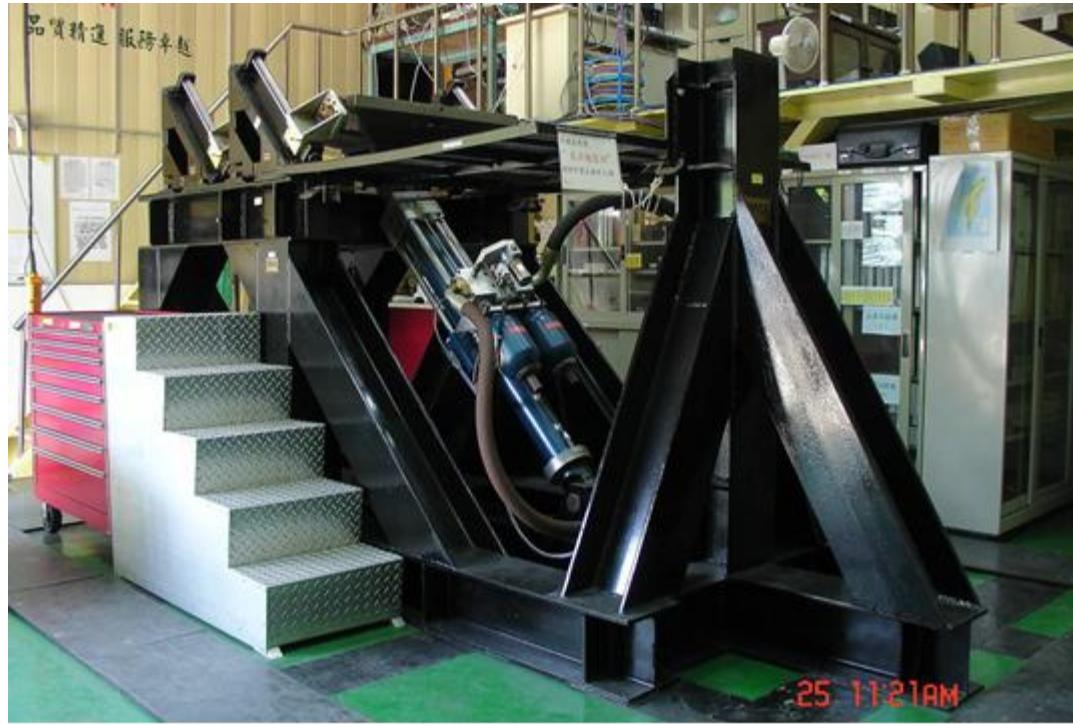
Shake Table of Seismic Test Laboratory

- Dependent Biaxial
- 45⁰ inclination of actuator
